FIELD INSPECTION

Project Name: <u>Mountain Valley Pipeline</u> Date:Thursday, August 16, 2018

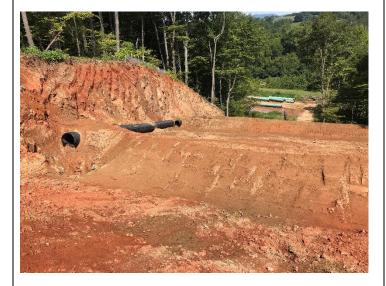
Fig. 1 Near station 13888+00 observed slope drain system not built per approval

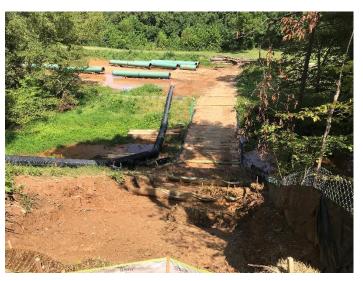
Fig. 2
Near station 13888+00 observed slope drain system not built per approval

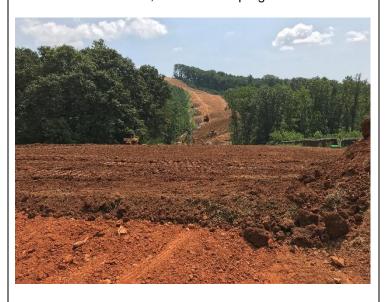
Fig. 3 Near station 13421+99, restoration in progress
